IRIS Touch NG Firmware Enhancements and Additions from Version 2.14 to Version 2.15

This document details changes to the IRIS Touch NG range from firmware Version 2.14 to Version 2.15.

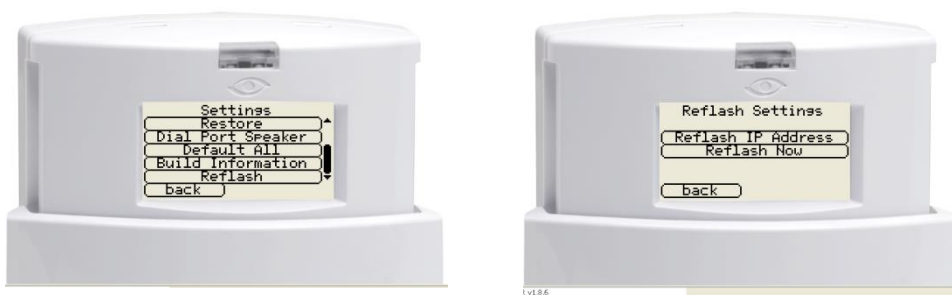
Alternatively, for local upgrade, connection to the reflash server can be instigated from the installer menu, Settings->Reflash:

The reflash IP address is set by default to Chiron's reflash server (195.59.117.164) and does not need to be changed unless another reflash server is to be used.
