## **IRIS Touch NG Firmware Enhancements and Additions from Version 2.16 to Version 2.18**

This document details changes to the IRIS Touch NG range from firmware Version 2.16 to Version 2.18.

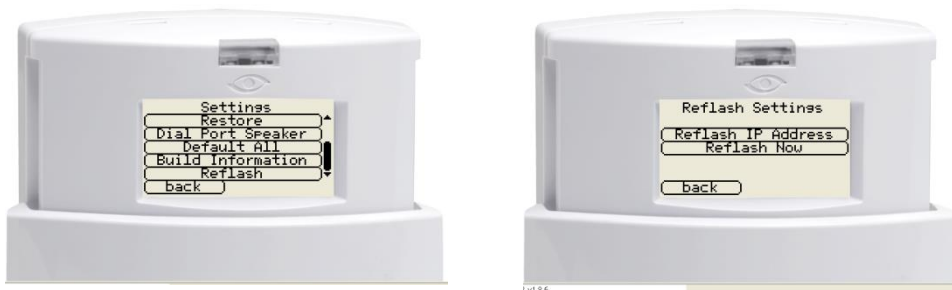
Alternatively, for local upgrade, connection to the reflash server can be instigated from the installer menu, Settings->Reflash:

The reflash IP address is set by default to Chiron's reflash server (195.59.117.164) and does not need to be changed unless another reflash server is to be used.
