IRIS Touch Firmware Enhancements and Additions From Version 1.9 to Version 1.9.2 (incorporating Version 1.9.1)

This document details enhancements and additions to the feature set of the IRIS Touch from firmware Version 1.9 to Version 1.9.2. An interim release (Version 1.9.1) is also incorporated.

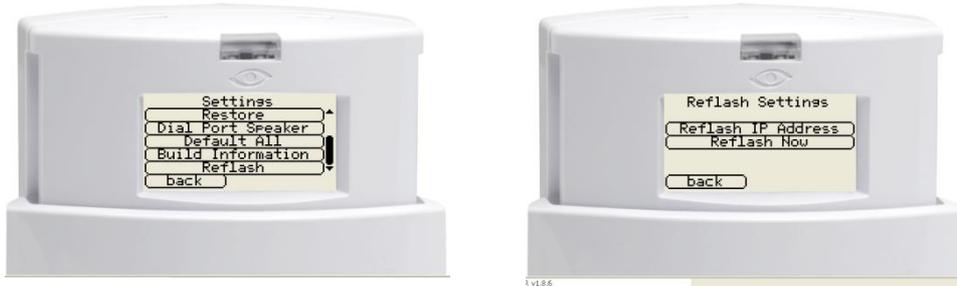
Connection to the reflash server can be instigated from the installer menu, Settings->Reflash:

The reflash IP address is set by default to Chiron's reflash server (80.176.196.134) and does not need to be changed unless another reflash server is to be used.

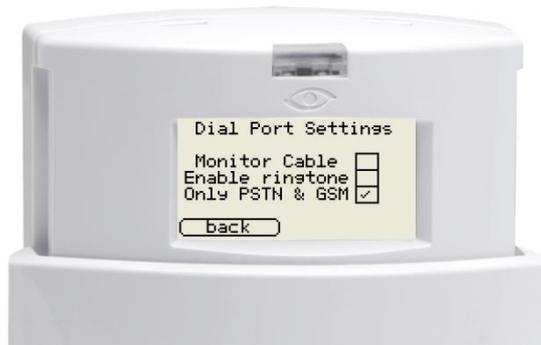
This is set up via the Settings->Panel Interface->Dial Port menu.

For applications such as speech diallers and elevator alarms, where voice calls as well as alarm message transmission is required, the dialler can be set so that an existing telephone line interface from the dialler can be connected directly to the dial port of the IRIS Touch and the phone number already programmed in the speech dialler will be routed, unmodified, to either PSTN (Touch 440R) or to GSM (Touch 440).

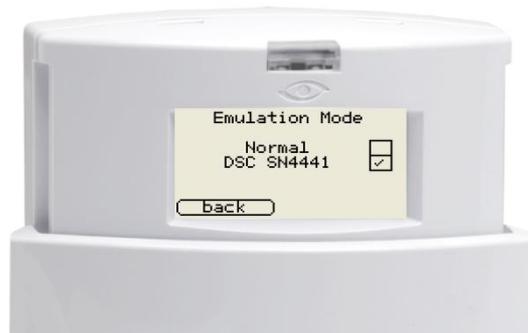
Note – this requires a different setting within the SN4441 menu of the DSC alarm panel.

To overcome the possibility that large messages sent over GPRS from the DSC SN4441 communicator get lost or duplicated, the serial interface speed to the SN4441 has been increased from 2400 baud to 9600 baud.
