IRIS Touch Firmware Enhancements and Additions From Version 1.9.3 to Version 1.9.5

This document details enhancements to the feature set of the IRIS Touch from firmware Version 1.9.3 to Version 1.9.5. Please note that version 1.9.4 was an internal release, not put out for general use.

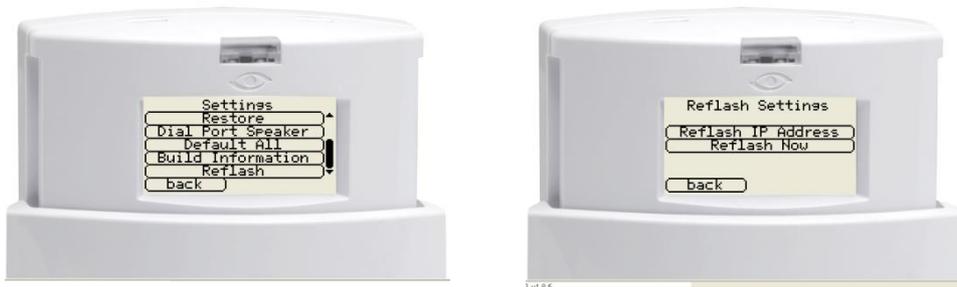
Connection to the reflash server can be instigated from the installer menu, Settings->Reflash:

The reflash IP address is set by default to Chiron's reflash server (80.176.196.134) and does not need to be changed unless another reflash server is to be used.
