IRIS Touch Firmware Enhancements and Additions from Version 1.19.1 to Version 1.19.4

This document details enhancements to the feature set of the IRIS Touch from firmware Version 1.19.1 to Version 1.19.4.

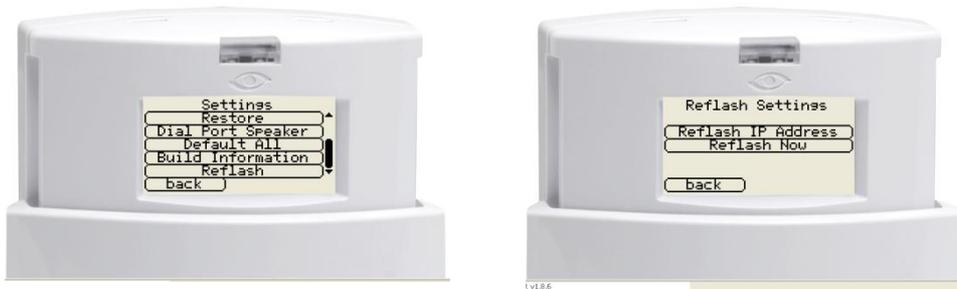
Connection to the reflash server can be instigated from the installer menu, Settings->Reflash:

The reflash IP address is set by default to Chiron's reflash server (195.59.117.164) and does not need to be changed unless another reflash server is to be used.
