IRIS Touch Firmware Enhancements and Additions from Version 1.12.8 to Version 1.12.9

This document details enhancements to the feature set of the IRIS Touch from firmware Version 1.12.8 to Version 1.12.9.

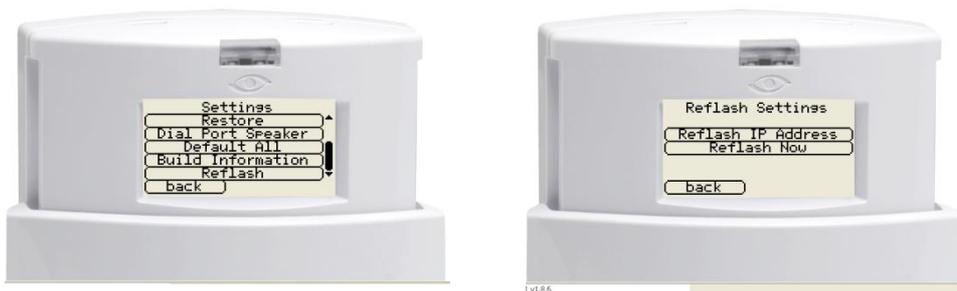
Connection to the reflash server can be instigated from the installer menu, Settings->Reflash:

The reflash IP address is set by default to Chiron's reflash server (195.59.117.164) and does not need to be changed unless another reflash server is to be used.
