IRIS Touch Firmware Enhancements and Additions from Version 1.19.7 to Version 1.19.8

Overview

This document details enhancements to the feature set of the IRIS Touch from firmware Version 1.19.7 to Version 1.19.8.

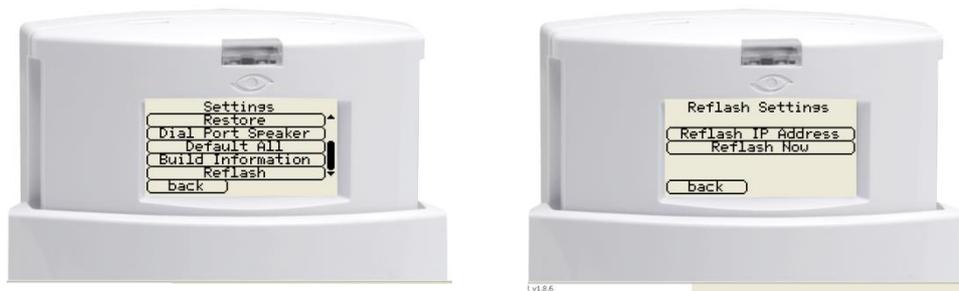
Connection to the reflash server can be instigated from the installer menu, Settings->Reflash:

The reflash IP address is set by default to Chiron's reflash server (195.59.117.164) and does not need to be changed unless another reflash server is to be used.
